CONNECTICUT RIVER BASIN
BELLOWS FALLS

MINARDS POND DAM
VT00154

PHASE I INSPECTION REPORT
NATIONAL DAM INSPECTION PROGRAM

AUGUST 1978

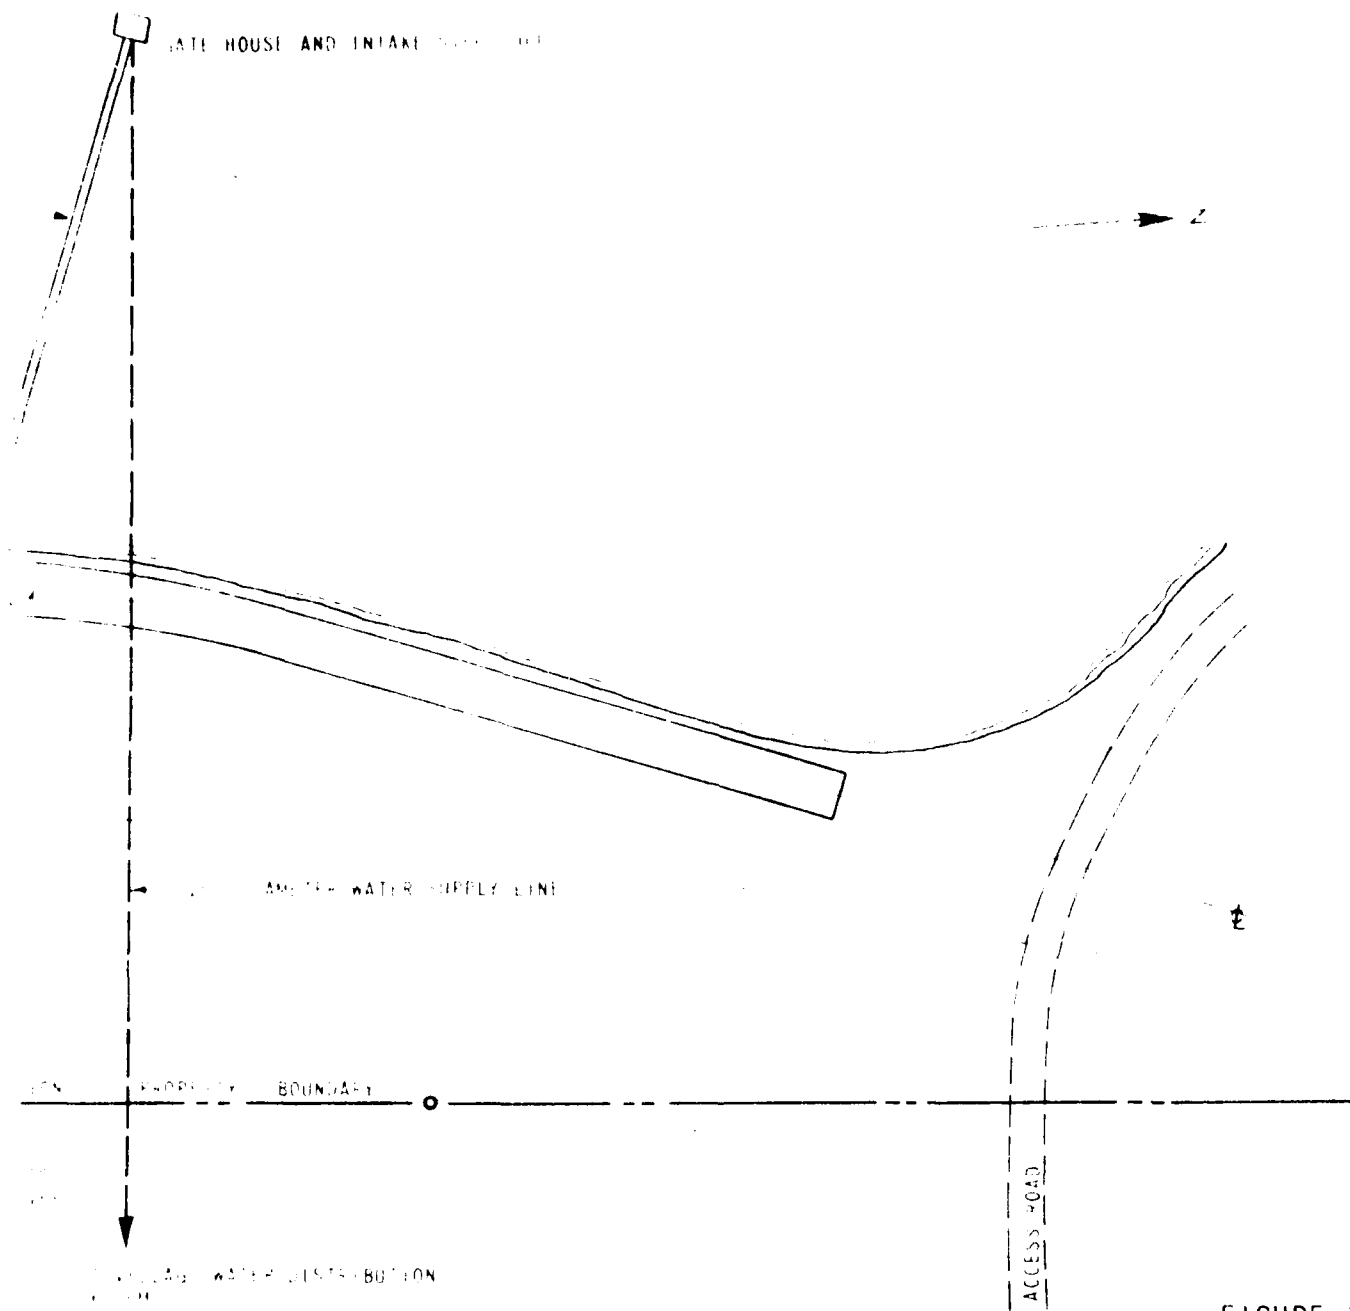
FIGURE 1

The trash rack is adequate but some debris has built up in front of the outlet conduit. The conduit is a 36-inch diameter corrugated galvanized metal pipe. As indicated in Fig. 1 the conduit has two bends before exiting into the discharge channel.

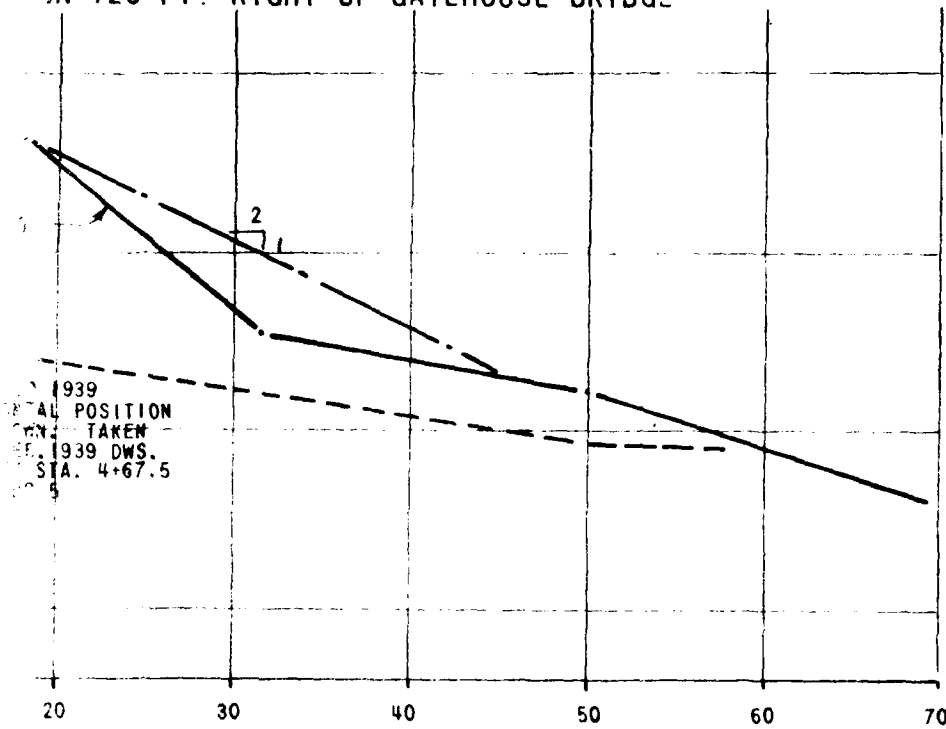
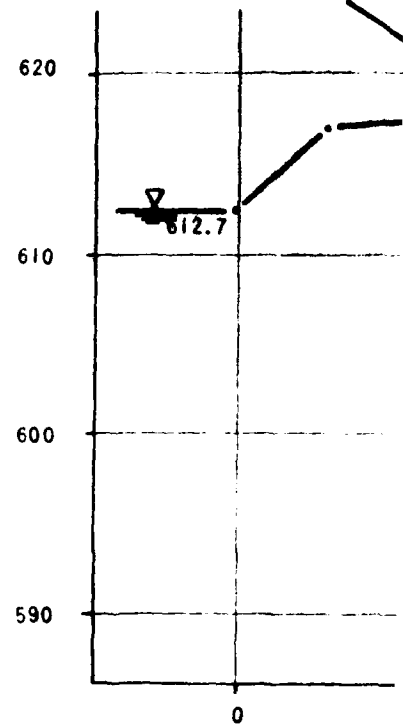
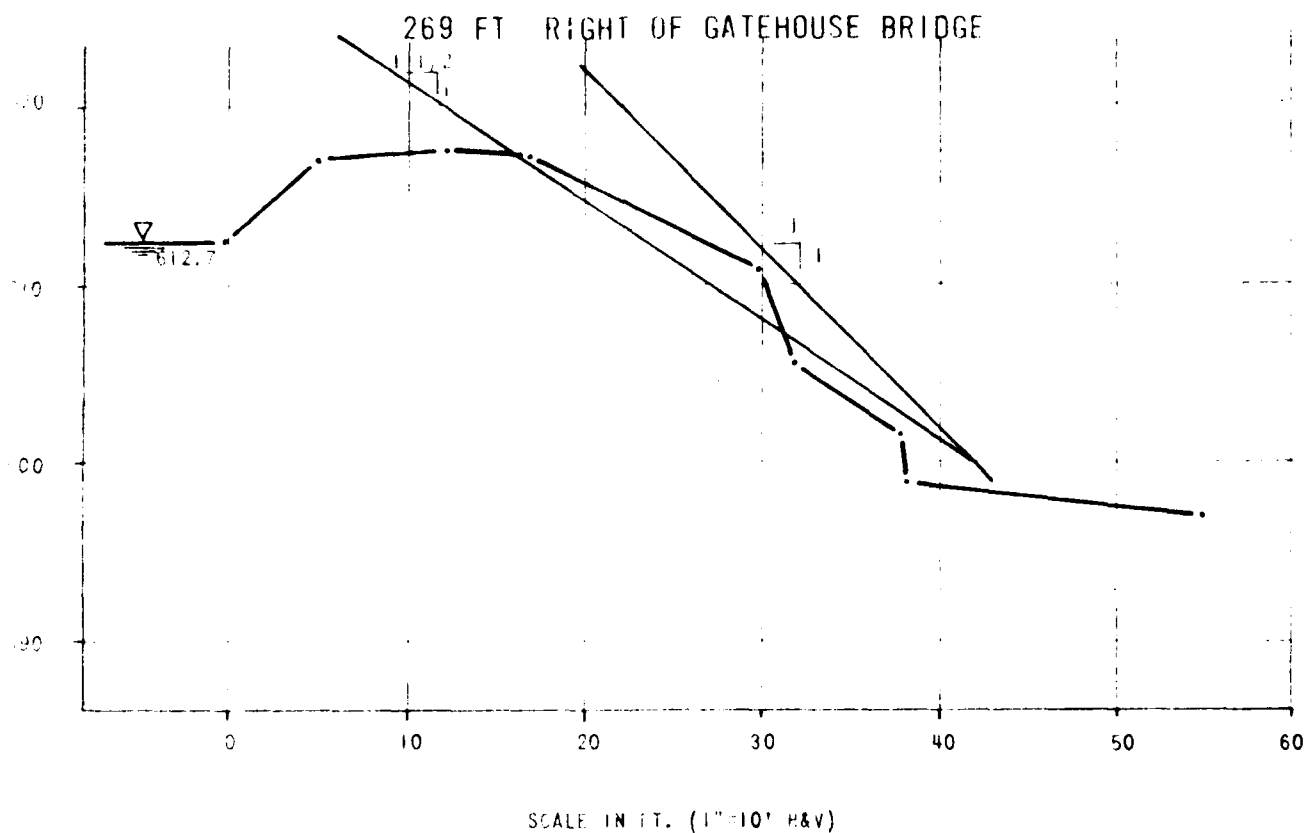
FIGURE 2

Of the proposed improvements shown in the 1939 plans in Appendix B, it is apparent from the field inspection that the downstream face of the dam was never filled to 3H:1V nor was the concrete spillway constructed. Fig. 2 shows two cross sections of the dam on June 21, 1978.
